## **Thorndyke Conveyor Macrovegetation Survey Port Orchard, Washington**

**Prepared for  
Fred Hill Materials**

**February 4, 2008  
12674-01**

Prepared by  
**Pentec Environmental**

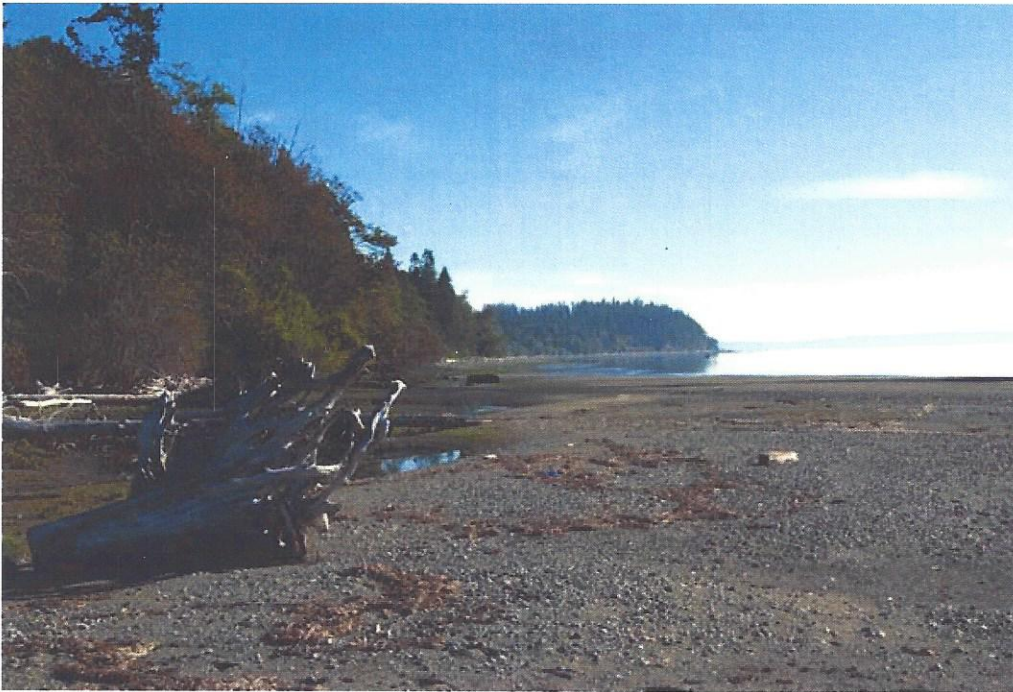
Intertidal substrate at the survey is composed of sand and silt likely originating from the bluff system along several miles of shoreline in either direction (Photograph 1). Wetlands are present, formed by seep water from sediment layers within the bluff and constrained by a significant storm berm made of coarser more gravel-laden material (Photograph 2). Along the high-tide drift line were scattered plants of *Atriplex patula*, *Salicornia virginica*, *Jaumea carnosa*, *Plantago maritima*, *Hordeum branchyantherum*, *Potentilla anserina*, and *Ambrosia chamissonis* (Photograph 3).

Photograph 1 - Survey area with varied substrate originating from bluff system upshore.

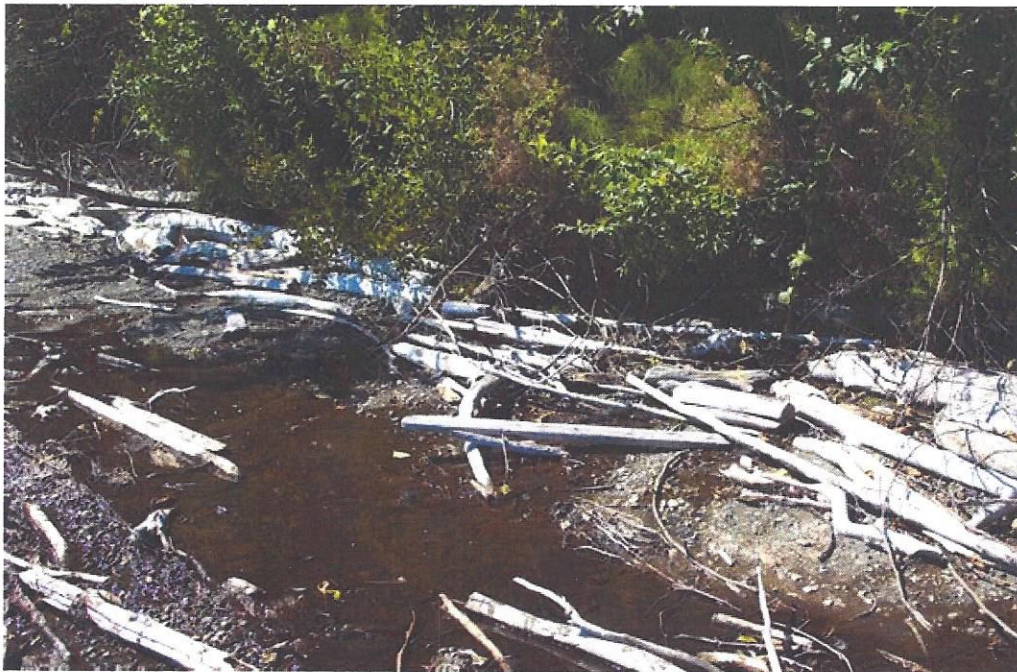
Photograph 2 - Wetlands formed by seep water from sediment layers within the bluff and constrained by a significant storm berm made of coarser more gravel-laden material.

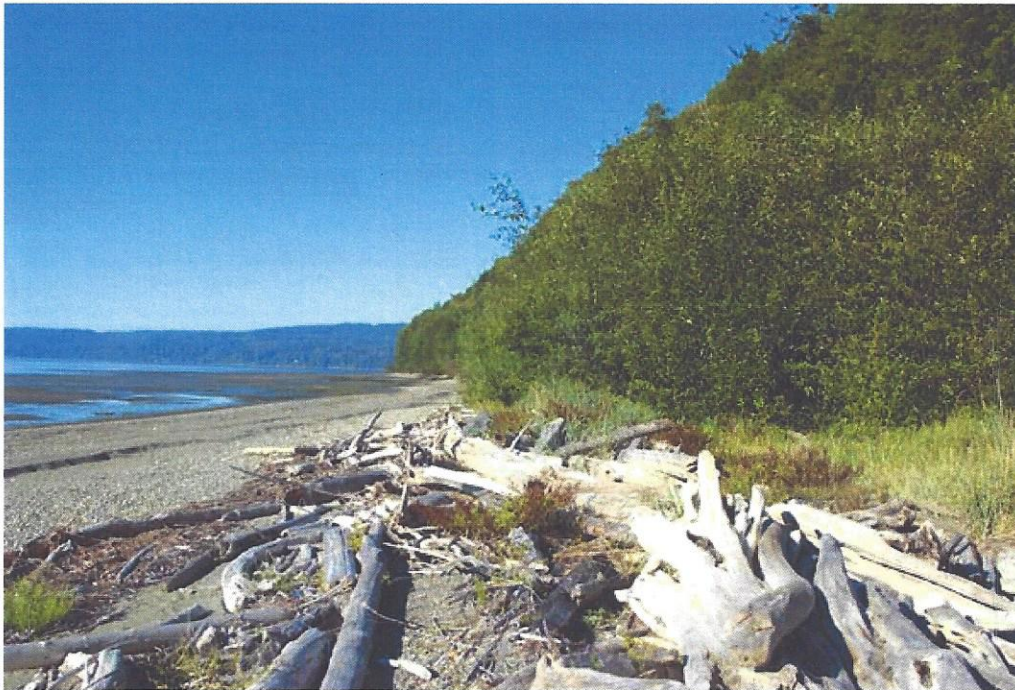
Photograph 3 - High-tide drift line composed of storm berm, large woody debris, and scattered plants (*Atriplex patula*, *Salicornia virginica*, *Jaumea carnosa*, *Plantago maritima*, *Hordeum branchyantherum*, *Potentilla ansirena*, and *Ambrosia chamissonis*).

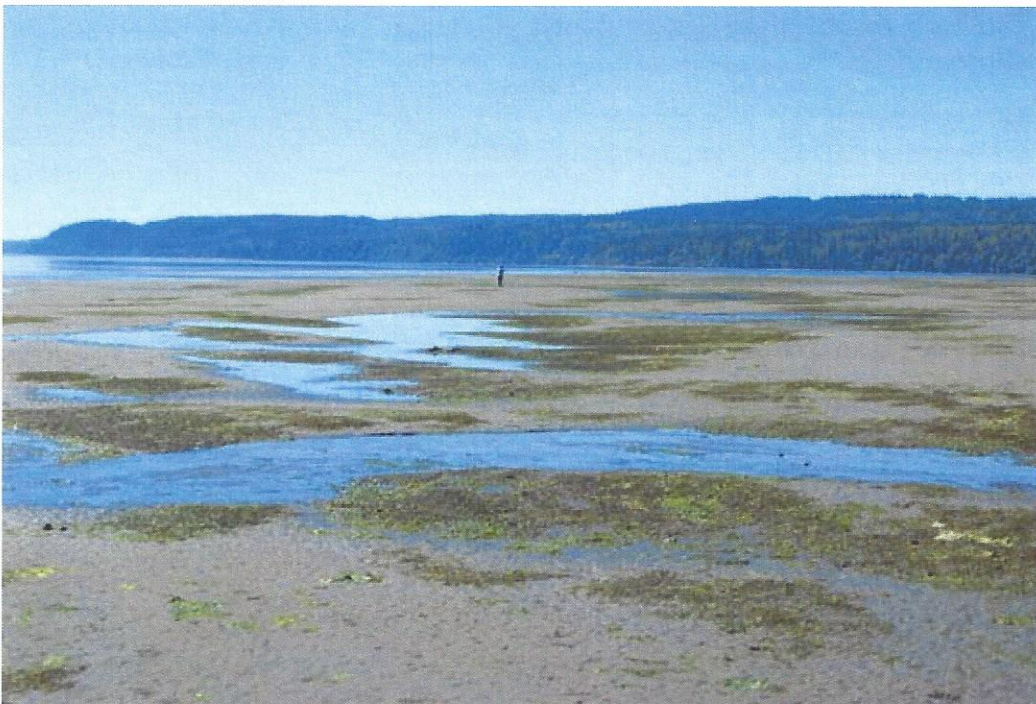
From +6 feet MLLW to 0-foot MLLW the sand flat supported scattered and discrete patches of *Z. japonica* (Photograph 4). Within each patch, shoots were very dense (Photograph 5) and fertile fronds were noted in patches located at lower elevations. Shoot-count densities of *Z. japonica* within representative patches ranged from 700 to 2,400 shoots per m<sup>2</sup>. The mean density in all patches surveyed was 1,400 shoots per m<sup>2</sup>. The band of *Z. japonica* patches tended to occupy the portion of the sandflat above the 0 MLLW mark and did not overlap with the more subtidal *Z. marina* population (Figure 2). *Z. japonica* is an introduced species that is known to occur throughout northern Puget Sound, although its distribution has not been well documented (Thom and Hallum 1990). This species of seagrass is thought to be an annual in Puget Sound, it is expected to be highly variable in space and time. This is especially true within the project area, where the advancing sand waves bury individual patches while new patches form in the lee of each wave.

Photograph 4 - Intertidal survey area with patchy *Z. japonica*.

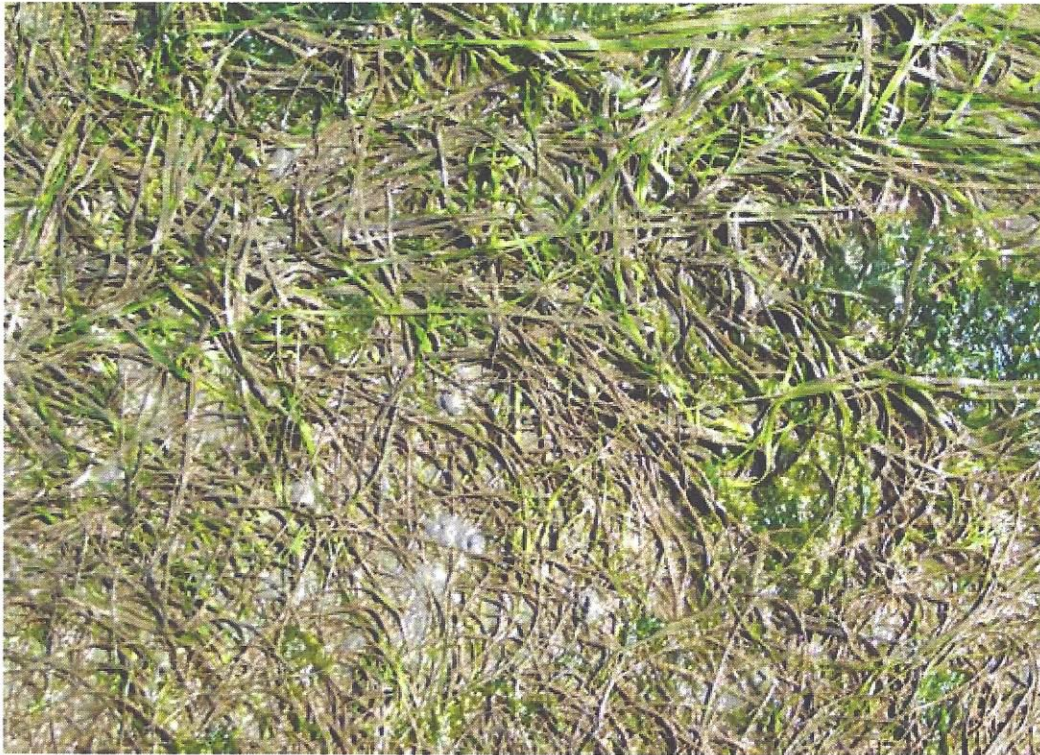
Photograph 5 - *Z. japonica* patch density.

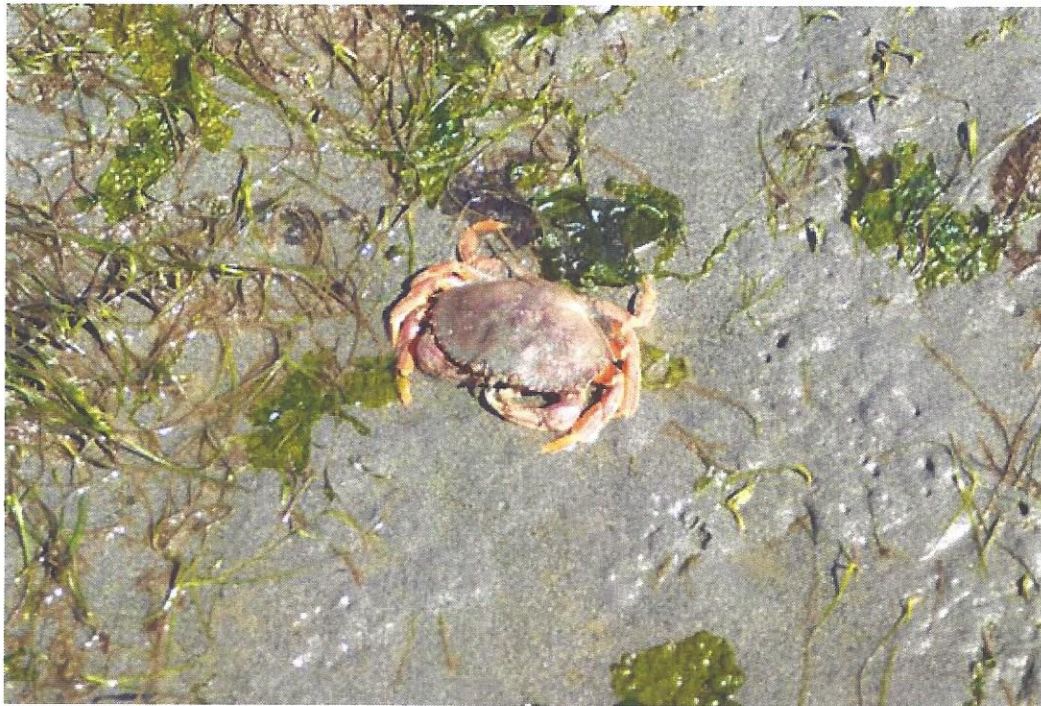
where high densities of live *D. excentricus* were documented. Occasional cockles, *Clinocardium nuttalli*, were also seen, and small holes of the burrowing polychaete *Nephtys* sp. were widespread. In shallow water along the shoreline and in the runoff channels, a few graceful crab (*Cancer gracilis*) were also present (Photograph 6).

Photograph 6 - Graceful rock crab (*Cancer gracilis*) in the intertidal survey area.

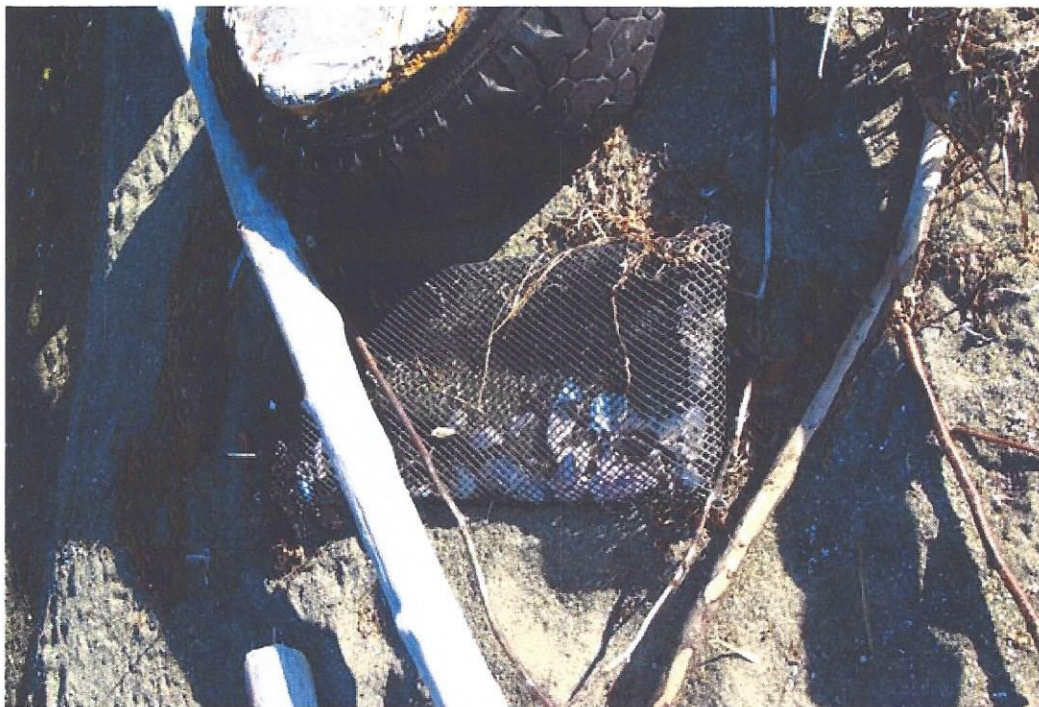
Minimal debris and anthropogenic impact was observed during the survey. The only obvious example was the presence miscellaneous plastic debris and containers in upper intertidal as well as the occasional Olympia oyster (*Ostrea conchaphila*; aka *O. lurida*) culture bag (Photograph 7) with attached ballast. This area is relatively undeveloped and reflects minimal direct human influence in the area.

Photograph 7 - Olympic Oyster (*Ostrea concaphila*) culture bag with attached ballast.
