SALMON AND STEELHEAD HABITAT LIMITING FACTORS

WATER RESOURCE INVENTORY AREA 17 QUILCENE-SNOW BASIN

WASHINGTON STATE CONSERVATION COMMMISSION

FINAL REPORT

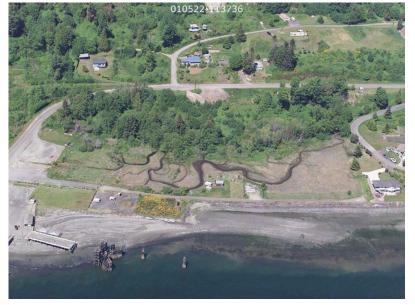
Figure 81. South Point Ferry and Salt Marsh. 2001 Ecology Nearshore Oblique Photo

A currently non-operating ferry terminal at South Point and adjacent housing development have impacted the shoreline and salt marsh habitat. Upon cursory inspection of the ferry terminal, Richard Brocksmith (2002) reports that riprap, a bulkhead and a groin, in addition to the massive creosote piling/pier system are impacting the

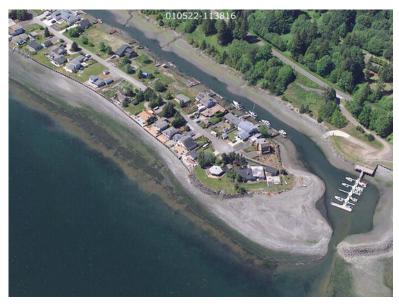
Figure 82. Bridgehaven. 2001 Ecology Nearshore Oblique Photo

A ferry terminal at South Point includes a large pier for car and pedestrian access but is not in use at this time. Twenty docks with a total of 30 boat slips are along the inside shoreline of the Bridgehaven spit, a significant impact to juvenile salmon in terms of predation and primary productivity. Dredging inside the southern spit at

Bridgehaven has deepened valuable intertidal and eliminated salt marsh

habitat. (Ron Hirschi, personal communication, 2002). Sampling by minnow trap, seine, and visual observation during the past year has failed to find any use of this area by juvenile salmonids. In contrast, tidal sloughs behind the eroding spit to the north (the remnant spit once a part of the Bridgehaven spit complex) are used by numerous chum and pink outmigrants (Hirschi and Doty, unpublished data, 2002).

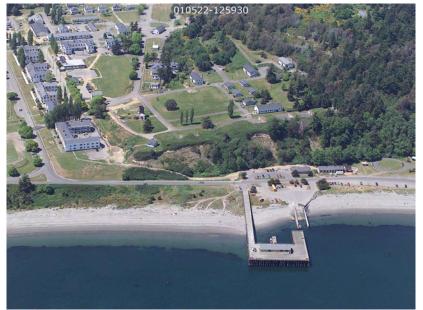
Figure 86. Pier at Fort Worden. Ecology 2001 Oblique Photo

The wharf at Fort Worden is built on densely lined piles to block sediment transport in

order to maintain boat basin depth. Historically, the boat basin has been periodically dredged as sediment continues to fill in the basin. The wharf should be modified to allow greater sediment transport from the drift cell to the west and provide for juvenile fish passage and continuity of the nearshore migratory corridor (TAG 2002).

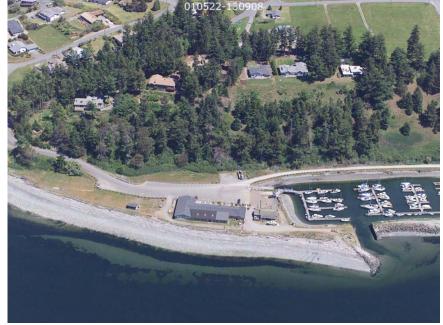
A marina along the southwestern shore of Cape George has seven piers with 50 slips (WDNR 2001). The entrance is to the marina is protected along the north side by a jetty

and is dredged during an extreme low tide each summer, and sometimes more often as necessary to maintain the opening. The jetty has been reduced in length from its original size (David Sullivan, personal communication, 2002). This will continue to be an issue since this section of shoreline is a depositional beach. The TAG recommends setting back the armoring and replacing existing riprap with softbank technology.

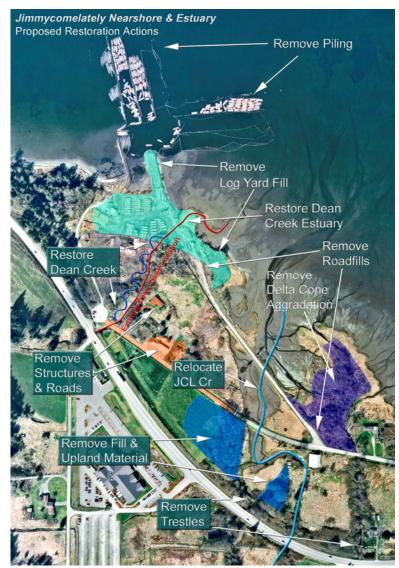
Fill associated with the old log yard, including the log yard road, should be removed

Figure 92. Jimmycomelately Estuary with Proposed Restoration Actions. Graphic by Randy Johnson, WDFW

- Reclaimed trailer park could become salt marsh habitat, although there is no evidence of an historic salt marsh
- Reconnect tidal channels of Jimmycomelately Creek
- Remove the county road
- Move Jimmycomelately Creek channel to the west to its historic location
- Remove the delta cone accretion of the old channel (Jimmycomelately) just low enough to be intertidal.
- Put in a new bridge with three spans over the newly configured Jimmycomelately Creek
- Remove the railroad trestle over the tributary to Jimmycomelately that carries stormwater from the casino and replace the trestle with a walking bridge.
- Add sinuosity to Dean Creek below highway 101
- Replace a culvert between two spits that truncates a valuable salt marsh south of Pitship Point with a bridge
